## Issues of highly retrogressive landslides in sensitive clays Champlain Sea Basin

3<sup>rd</sup> International workshop on

Landslides in sensitive clays

Technical tour

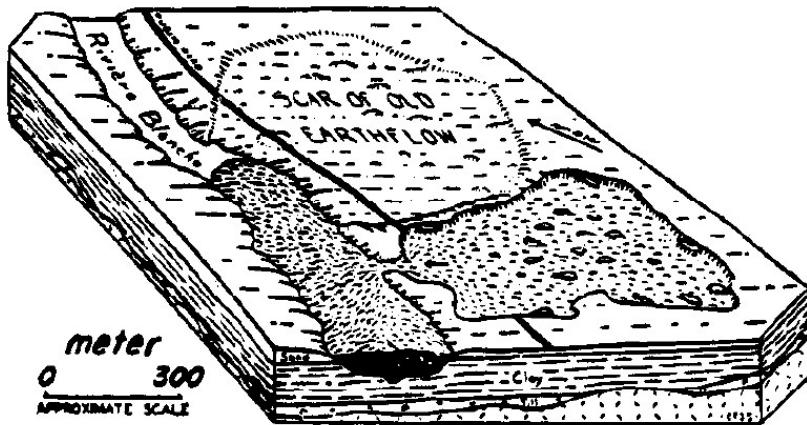
Figure 3: Sketch by Sharpe (1938) of the 1898 landslide in Saint-Thuribe, later used by Terzaghi and Peck in all three editions of their book *Soil Mechanics in Engineering Practice*.

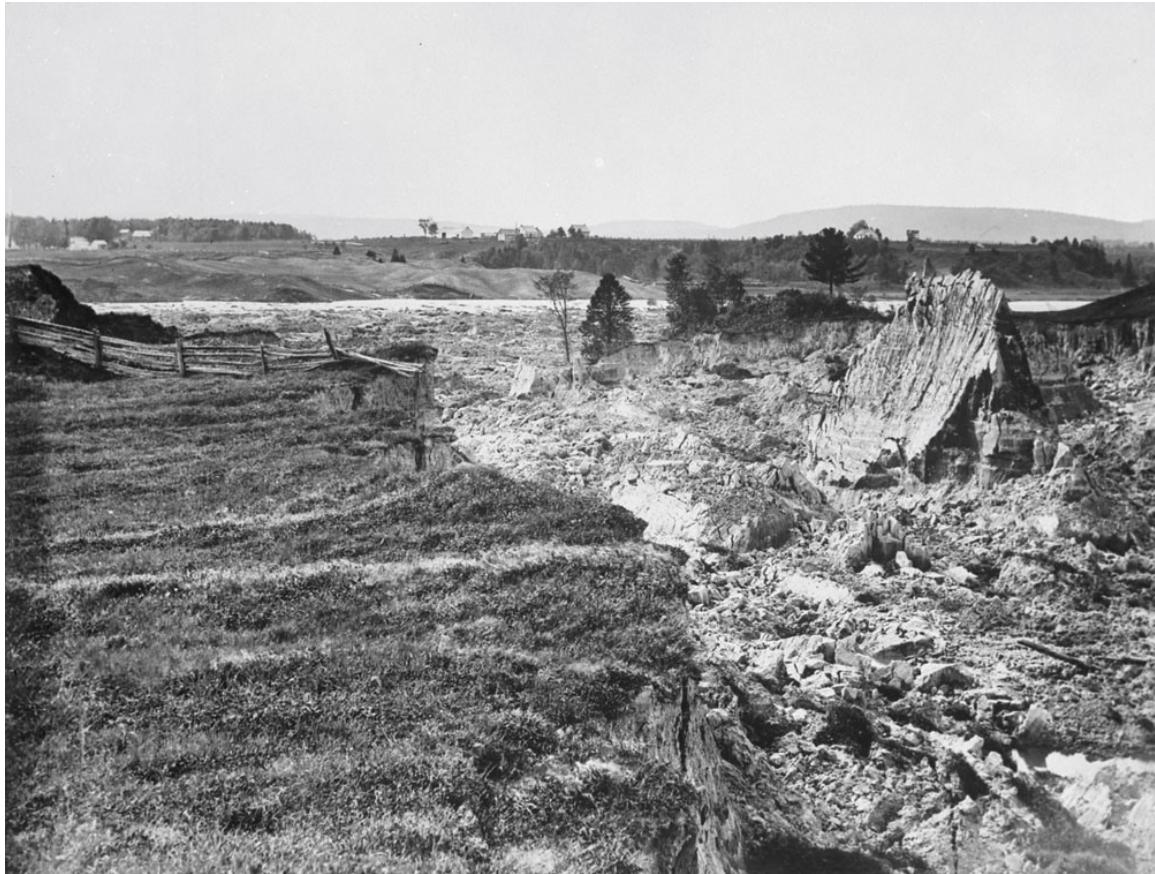
*Figure 4: Historical photograph showing a horst in the 1898 landslide. View facing the bottleneck part of the slide. (Source: Library and Archives Canada, PA-050914)*

However, this case was recently re-evaluated by Therrien et al. (2025), who classified it as a composite flowslide-spread type, as several historical photos (Figure 4) and eyewitness accounts from the time clearly indicate the presence of horsts. In his 1899 report, Dawson noted: "The floor of the depression was formed by irregular mounds, pyramids, and blocks of clay [...]. The composite landslide case at Saint-Luc-de-Vincennes in 2016, well documented by Tremblay-Auger (2021), provides a compelling example of a pear-shaped

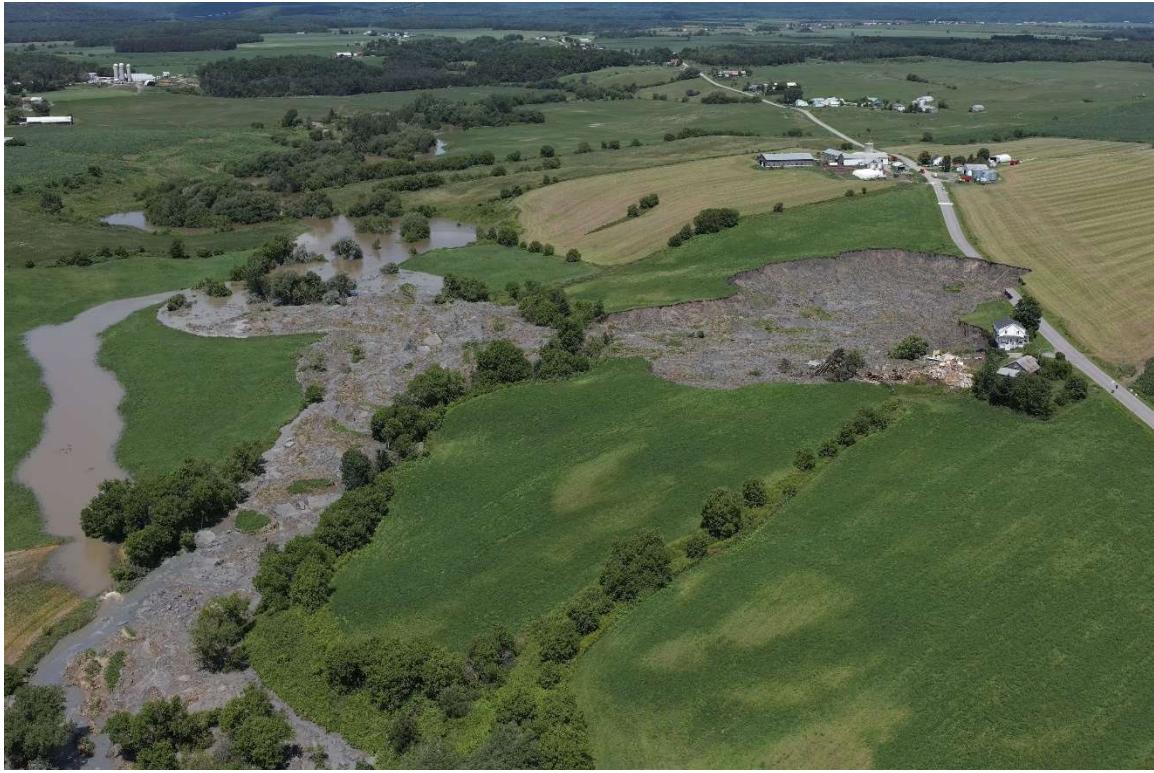
Figure 6: Overview of the landslide scar and part of the debris obstructing the Blanche River on July 16. Note the new channel the river has started to follow on the left. (Source: MTMD – DJI\_20250718131933\_0159)

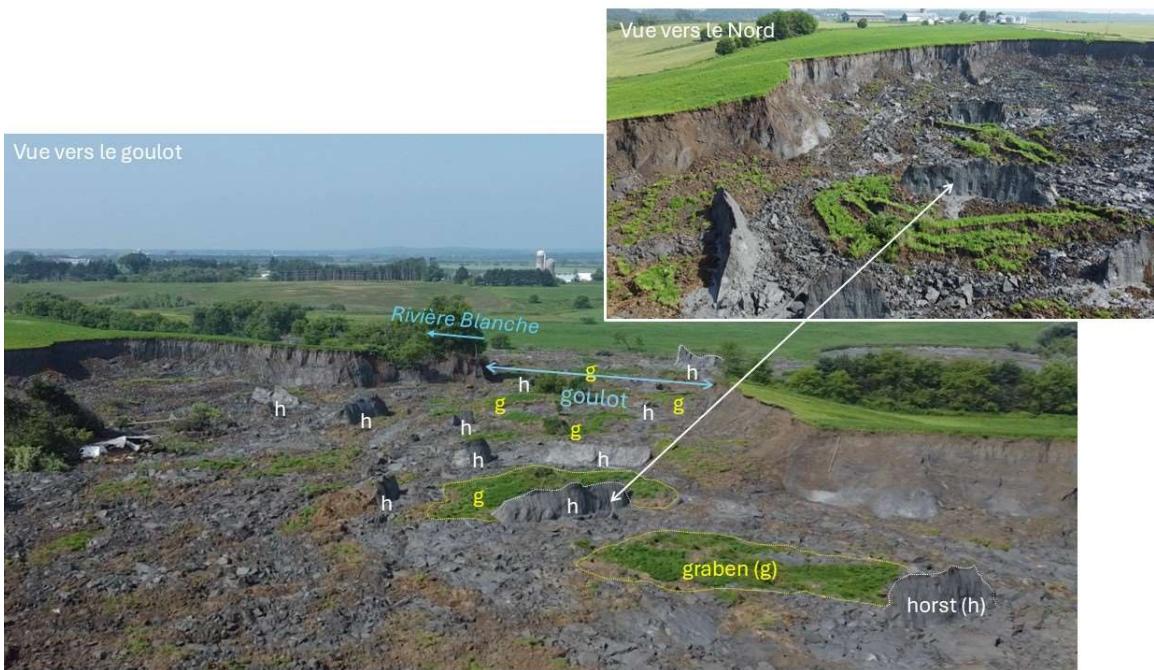
Figure 7: View of horsts (h) and grabens (g) inside the landslide scar. (Source: MTMD)

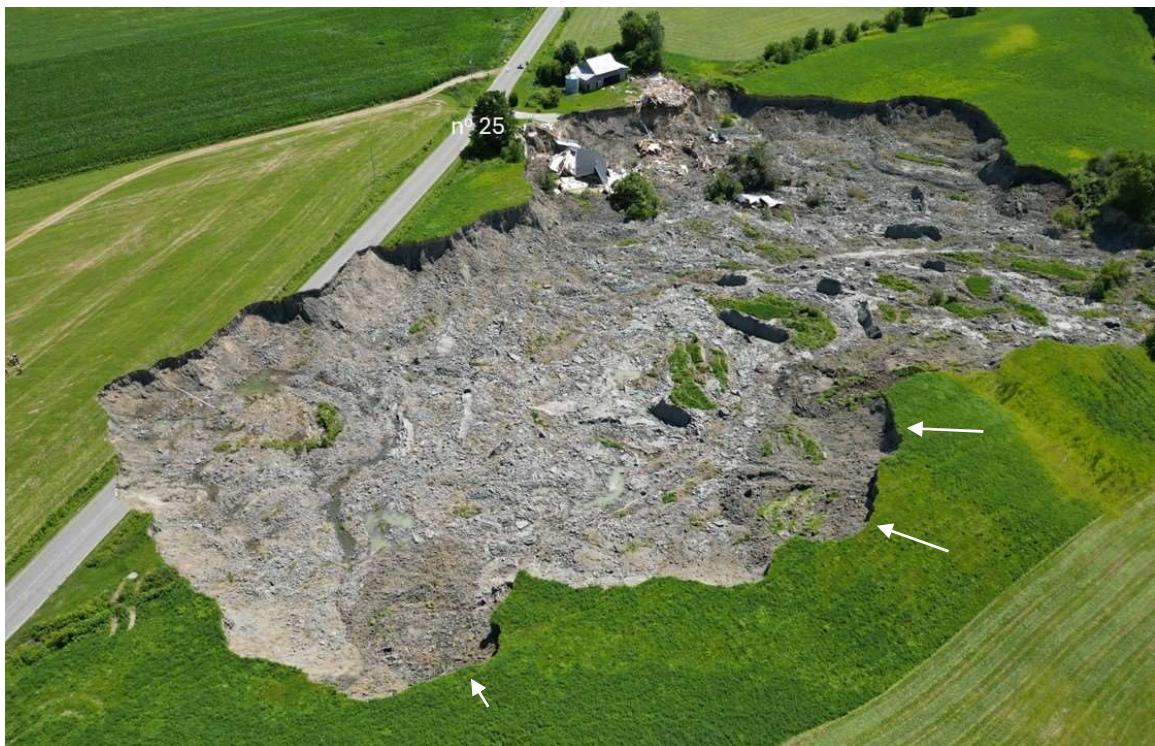
*Figure 8: Aerial view of the landslide taken by drone on July 20, 2025. The photo shows the now-destroyed residence no. 25, as well as recent rotational failures (white arrows) around the scar. (Source: MTMD)*

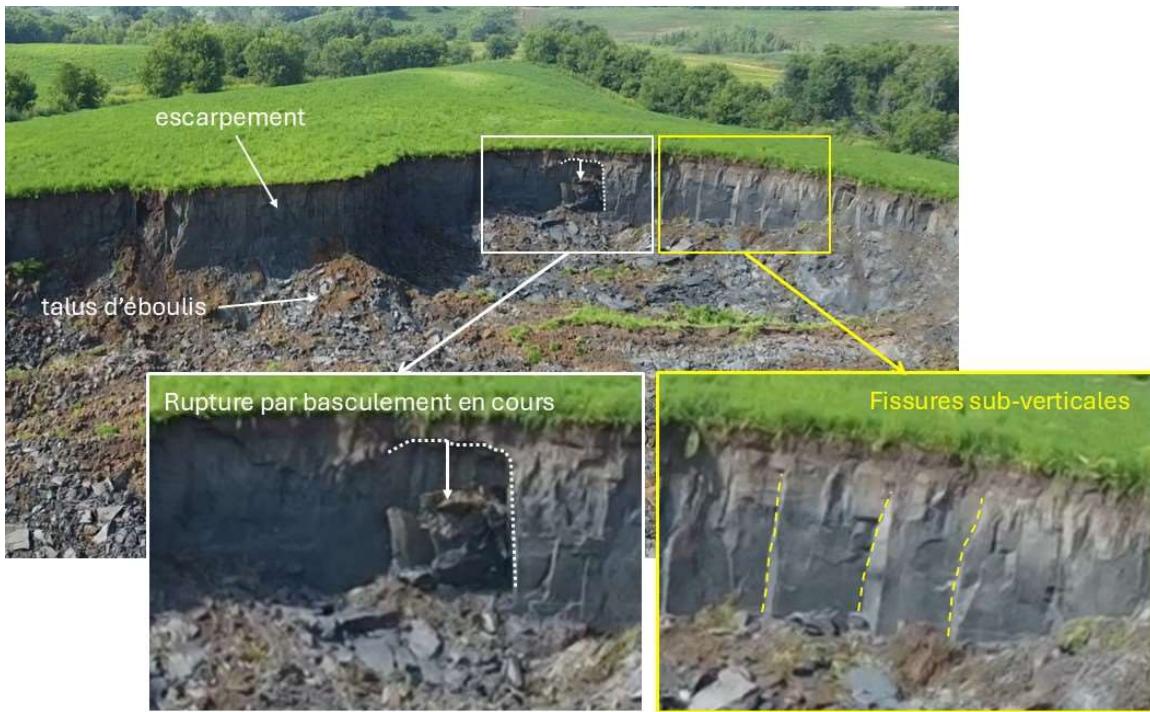
Figure 9: Drone photos from July 16, 2025, showing subvertical cracks around the scar, facilitating toppling failures. (Source: MTMD)

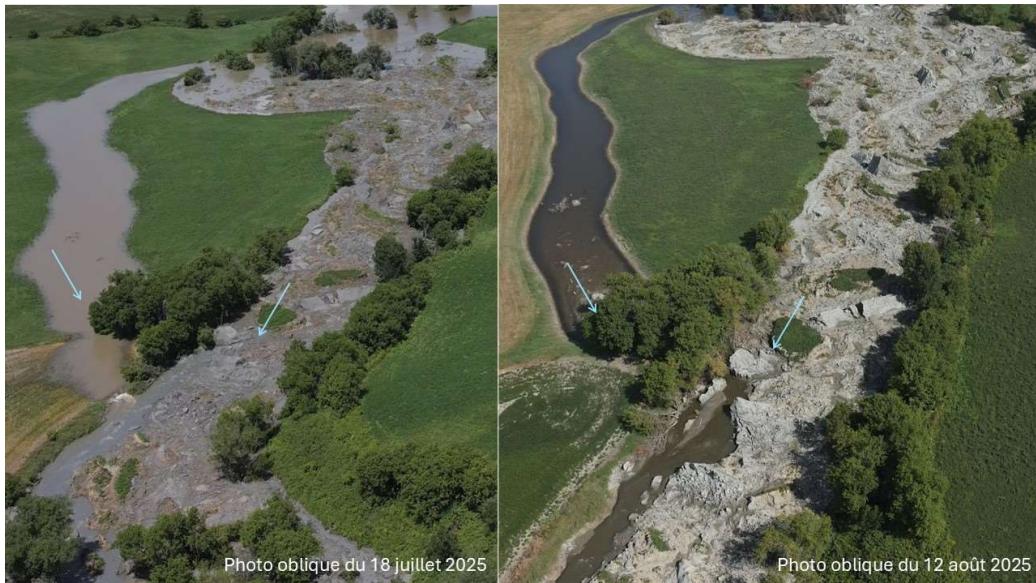
Figure 12: Drone photos at the confluence between the main Blanche River channel and an old branch now carrying the river's flow after the landslide. Arrows indicate flow direction. (Source: MTMD-DGG)

Deschambault and Portneuf. The debris accumulation obstructed the Blanche River for several hours, causing upstream flooding. However, no buildings or infrastructure appear to have been affected by this temporary water retention. On the other hand, the debris significantly altered the river's hydraulic dynamics, including displacement of erosion points and the use of the old river channel on the western valley slope. Due to the large volume of debris, hydraulic disruptions in the Blanche River are expected to persist for several months.

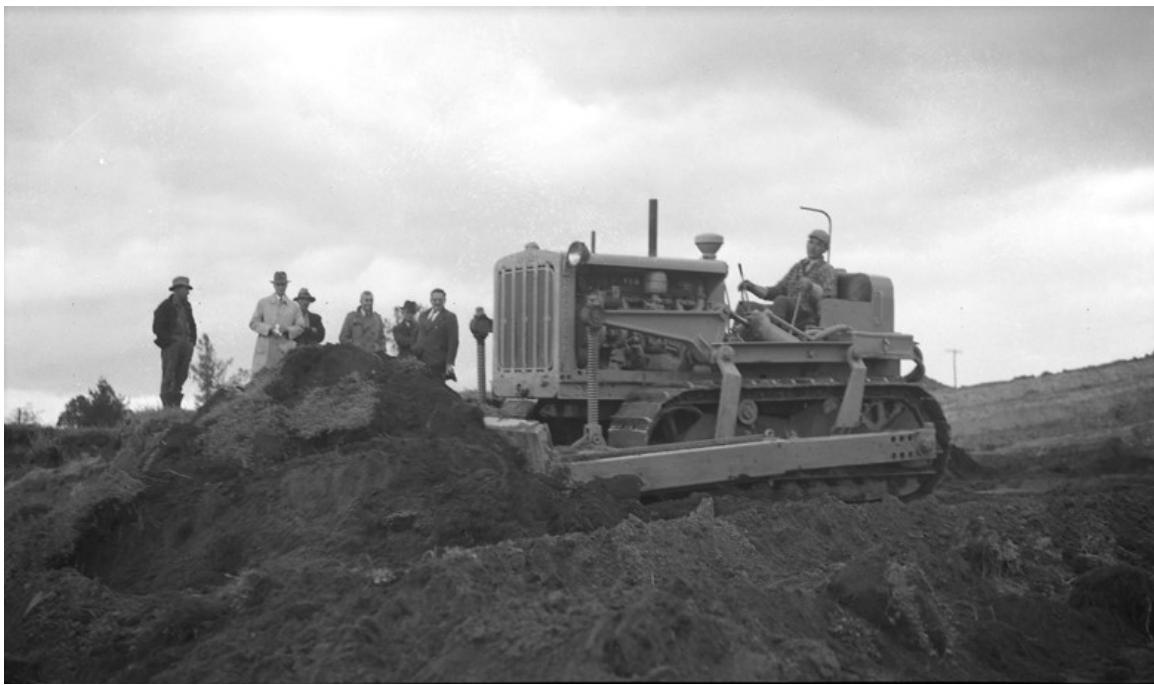
*Figure 3 : In the 1940s, a program run by the Department of Agriculture allowed farmers to borrow modern equipment to optimize arable land and level of the ground in the landslide site of May 13, 1939 served as a test for this public policy. (Source : Bibliothèque et Archives nationales du Québec, E6, S7, SS1, D2, P381)*

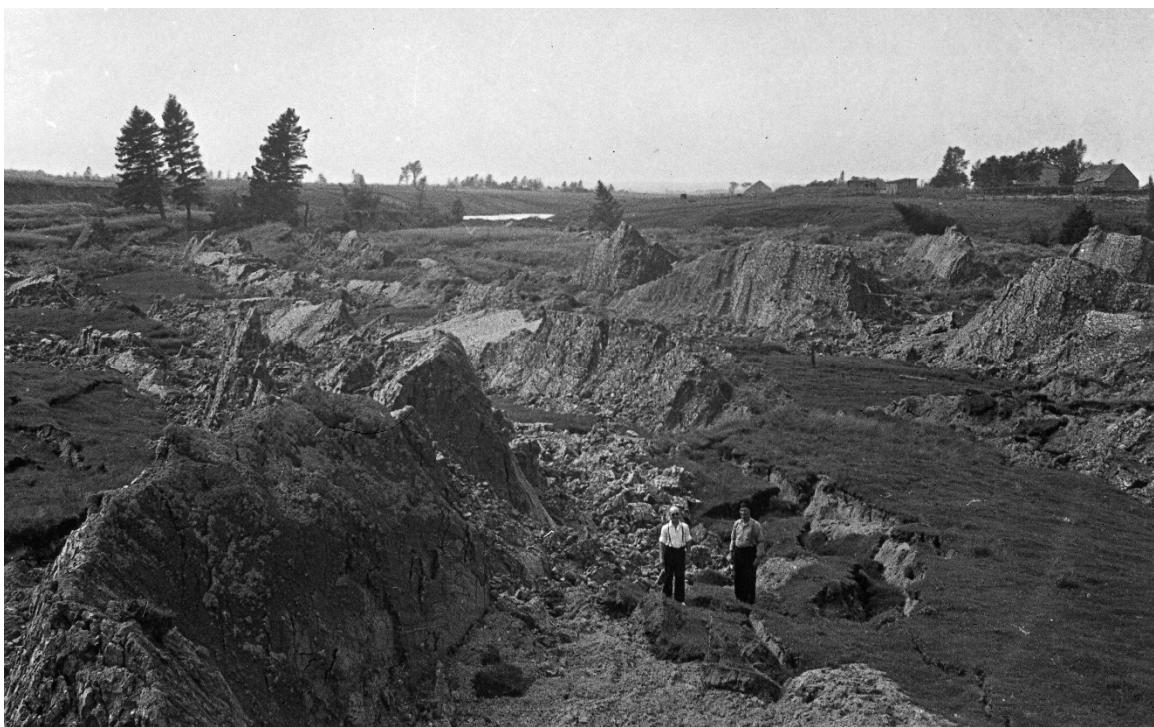
*Figure 4 : Barely three months after a 6-hectare landslide along the À Veillet River, another major landslide occurred in Sainte-Geneviève de Batiscan, along Marchand Creek. (Source: Laval University Collections, photo 1653)*

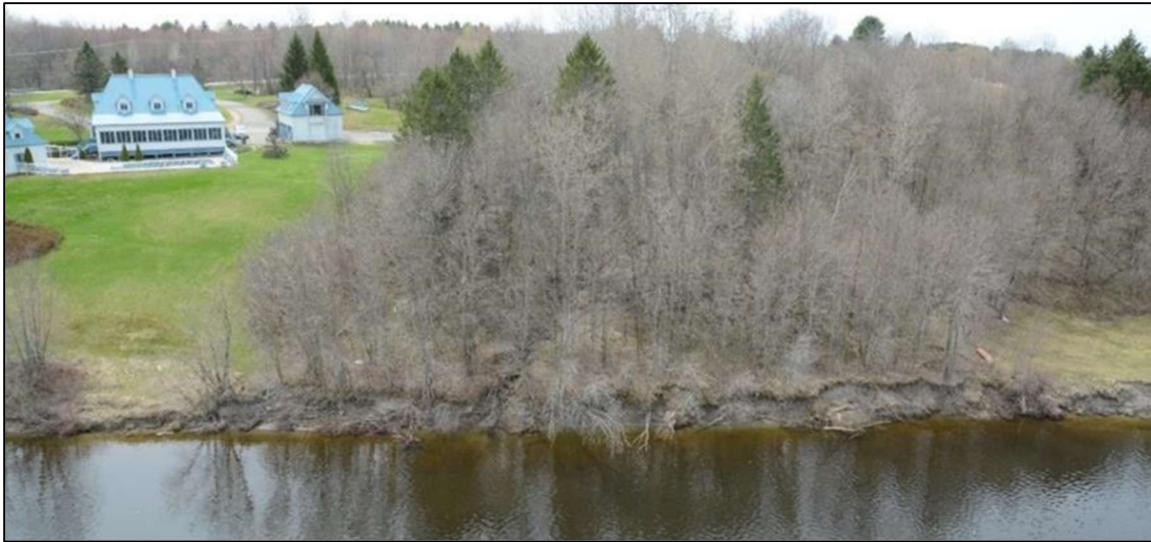
Figure 8 : Helicopter view of the riverbank opposite Rue des Brumes, showing signs of active erosion at its base.

Results of soundings and drilling carried out on the opposite bank confirmed that the clayey soils forming the slope were indeed prone to the development of HRLs, which was to be expected given the numerous scars left by such movements in the area (Figure 6). According to borehole 26026, located at the top of the slope, liquidity index varies between 1.3 and 1.6 throughout the clay column forming the bank (Figure 7). And although the potential starting point was located within an old first-generation scar, the part of the slope directly adjacent to the river, consisting of intact clay, remained approximately 14 m high, and at a “critical” slope, considering the properties of the clay. In addition, the foot of the slope showed signs of active erosion (Figure 8).

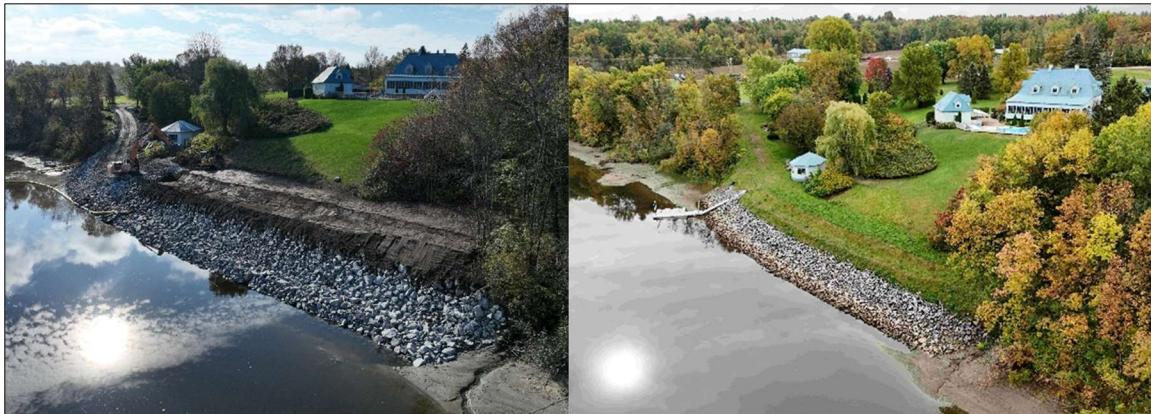
Figure 13 : *Stabilization work opposite Rue des Brumes, on the Batiscan River. Left: work in progress. Right: 11 months after completion of the work.*

Upon completion of this stabilization project the area potentially exposed to landslides, which had been identified in the 1980s, was removed from the landslide hazard map, protecting not only the residents of Rue des Brumes, but a few more homes and a segment of the road on the opposite bank, which were at risk of being swept away by a second generation of HRL. This also freed up some potentially buildable land, which was another advantage for the municipality.

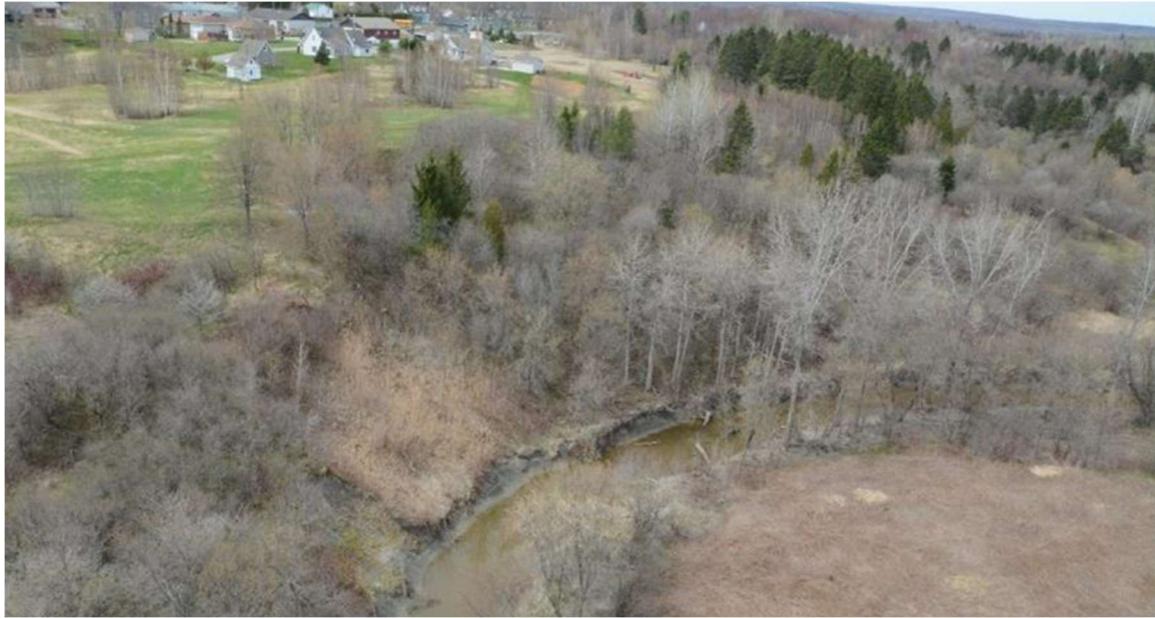
Figure 15 : View of erosion at the foot of the slopes along the Veillet River near the village of Sainte-Geneviève-de-Batiscan. Total height of the slope: 26 m. (Source: MTMD – 2017).

by active and sometimes very severe erosion by the river (Figure 15), which is contributing to a gradual decrease in the overall stability of the slope.

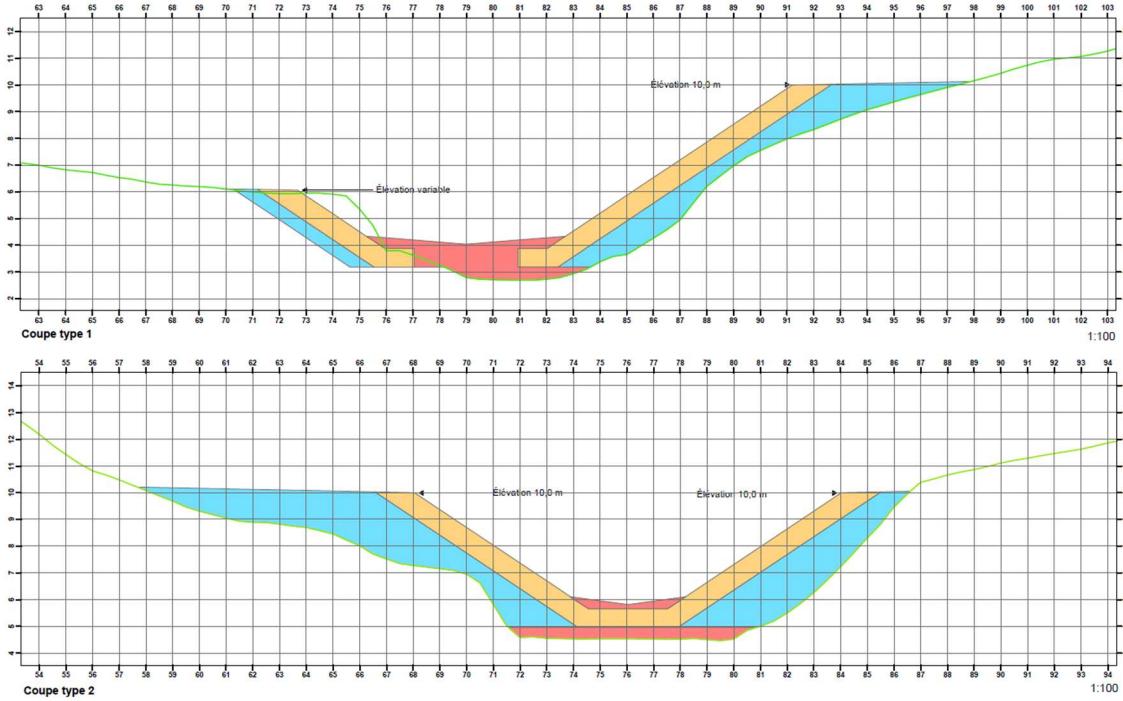
*Figure 16 : Typical cross-sections of the design chosen for the prevention works on the À Veillet River. Cross-section 1 (top): counterweight at one bank with erosion protection embedded in the opposite bank. Cross-section 2 (bottom): riprap counterweight at both banks. The blue colour corresponds to filter layer, the red to a material with a wider range of particle size graded, and the orange to riprap.*

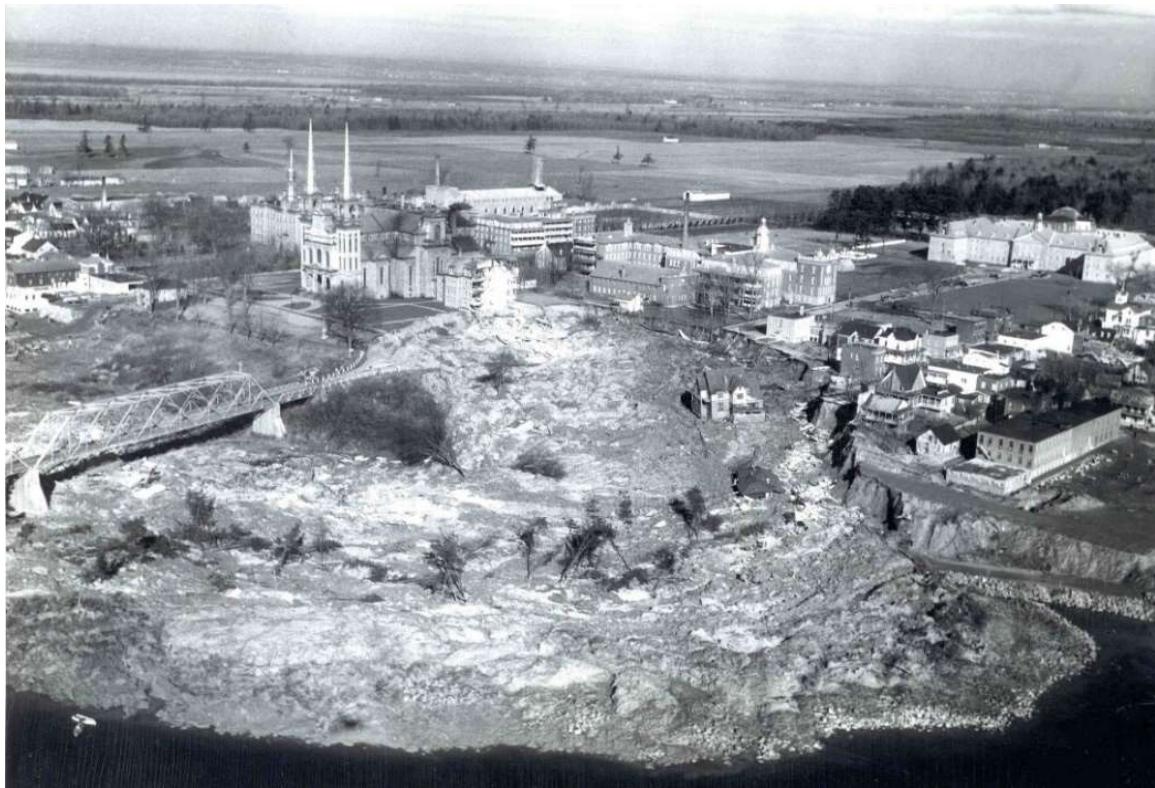
*Figure 1 : Overview of the 1955 landslide. Note on the right side of the photo the path leading to the toe of the riverbank, with a very steep slope. The riprap previously laid at the base of the riverbank is visible at the end of the debris on the right side of the photo. (Source : Gouvernement du Québec)*

An overview of the landslide and a view of the river facing upstream are presented in Figures 1 and 2, respectively. The width of the scar was measured at 125 m, with a retrogression distance of 198 m. The average depth of the failure surface was approximately 10.5 m, and the height of the backscarp, shown in Figure 3, was 6 m.

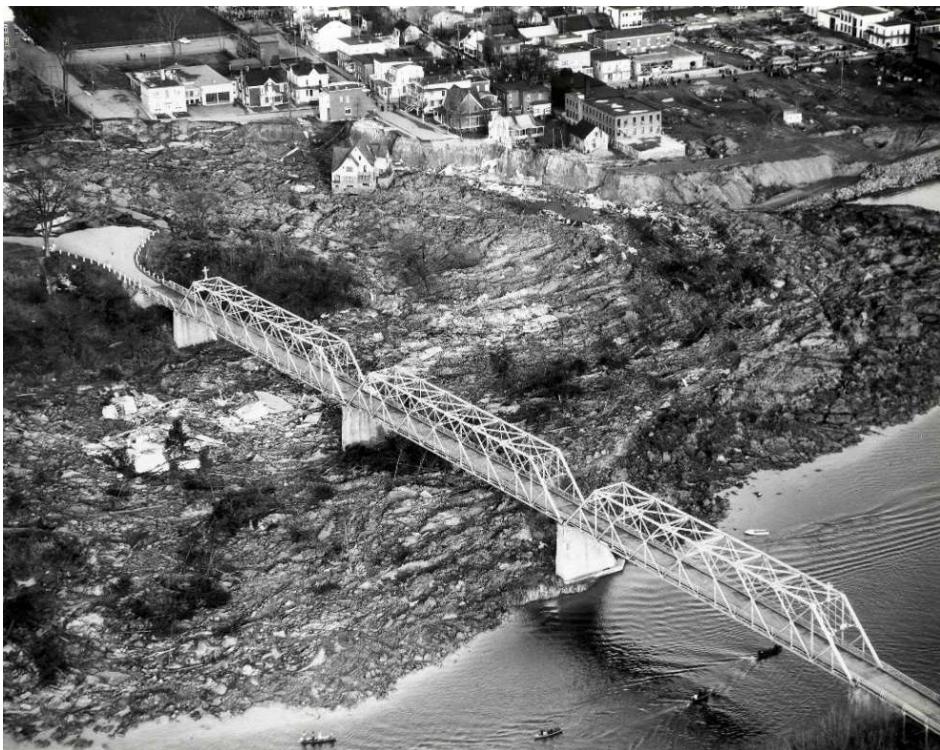
Figure 2 : View of the landslide looking upstream. (Source : Canada Wide Photos)

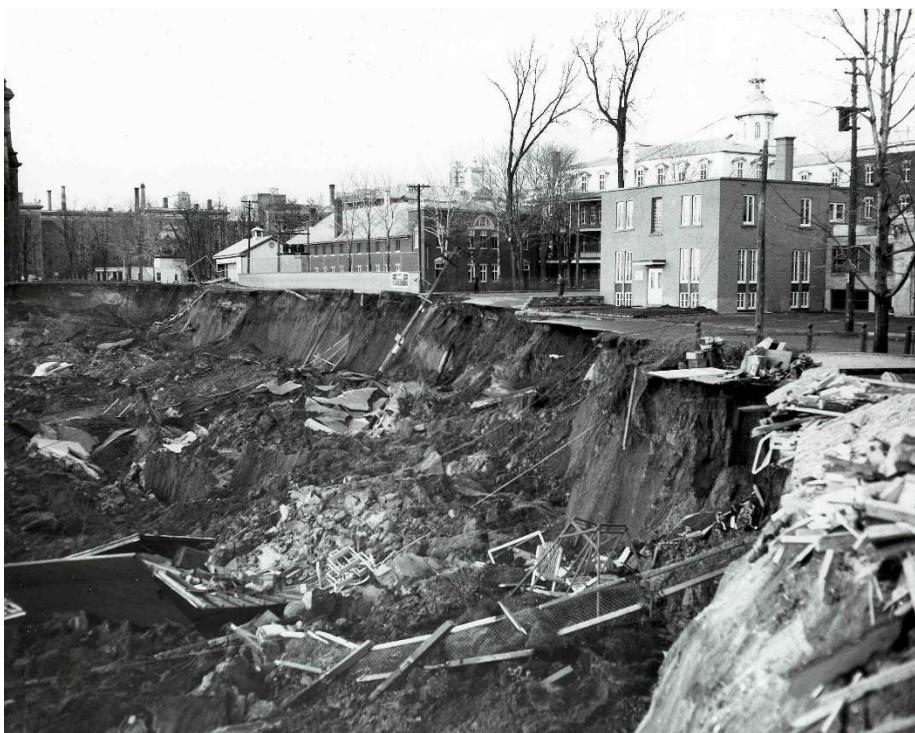
Figure 3 : Backscarp northeast of the scar. (Source : Canada Wide Photos)

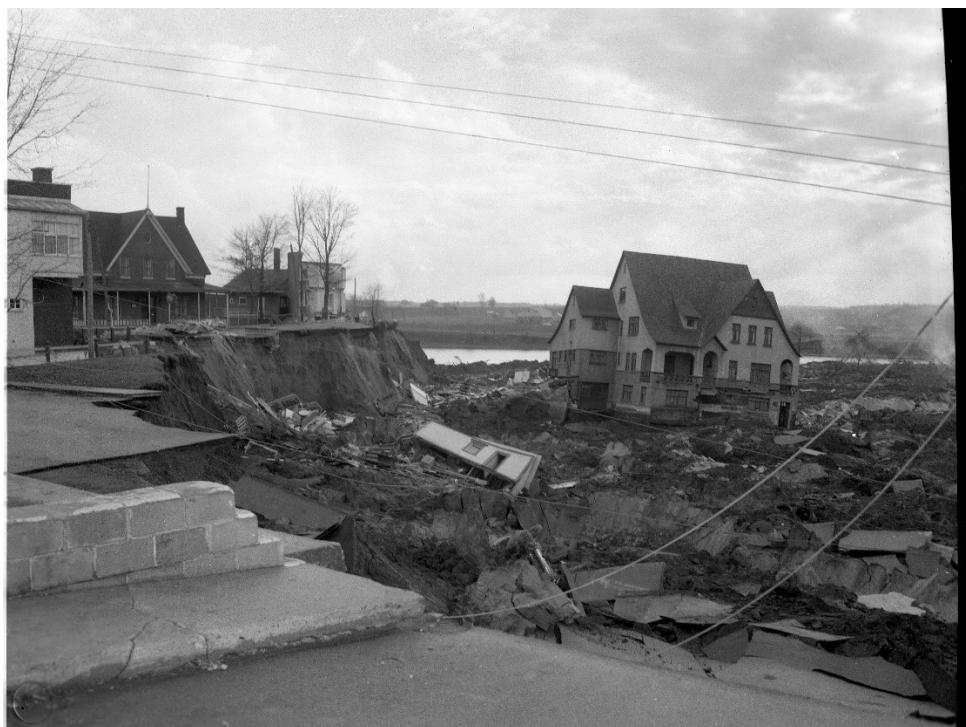
*Figure 5 : Home built on a foundation raft that remained intact in the scar left by the landslide.*  
(Source : Appartenance Mauricie, 3042-074)

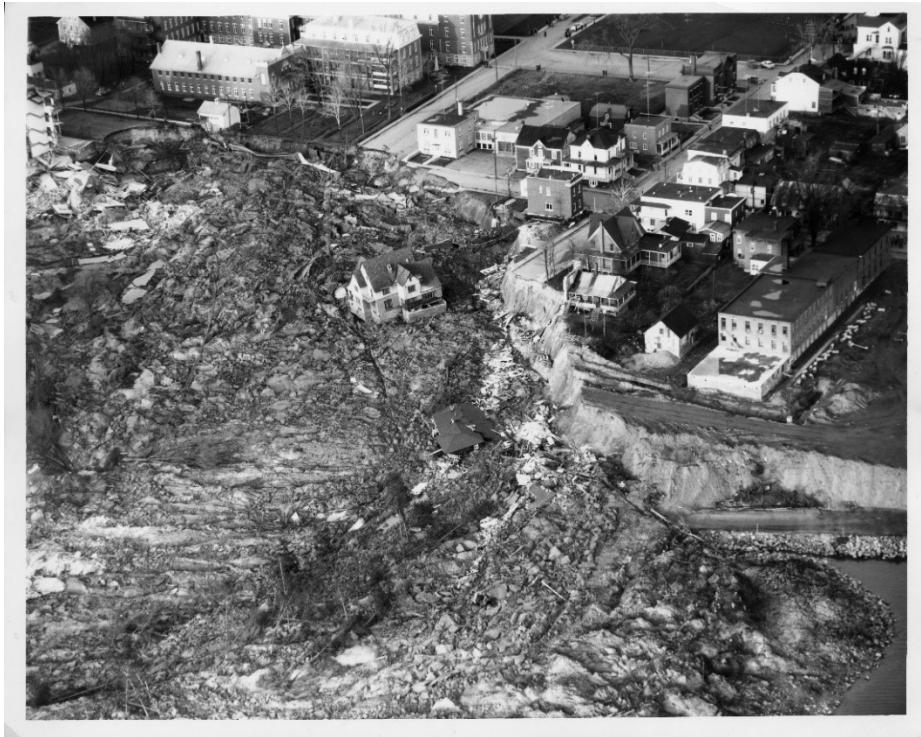
Figure 6 : Homes destroyed or partially destroyed. Like in figure 1, note on the right side of the photo the path leading to the toe of the riverbank, with a very steep slope. (Source : Canada Wide Photos)

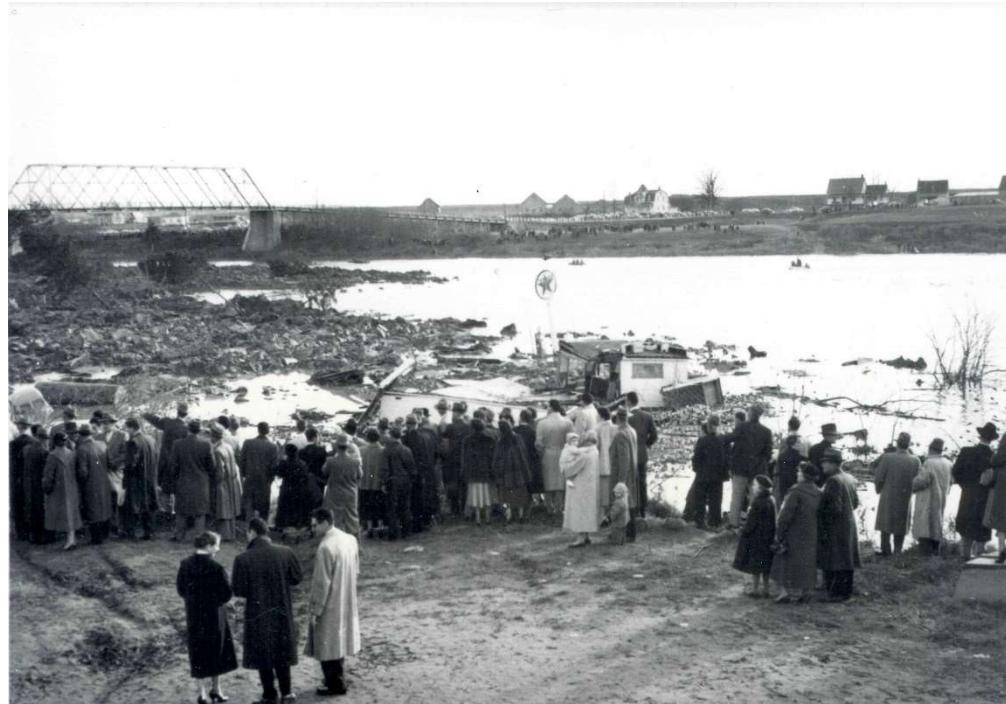
Figure 7 : Service station swept away by the landslide. (Source : Ministère des Transports et de la Mobilité durable)

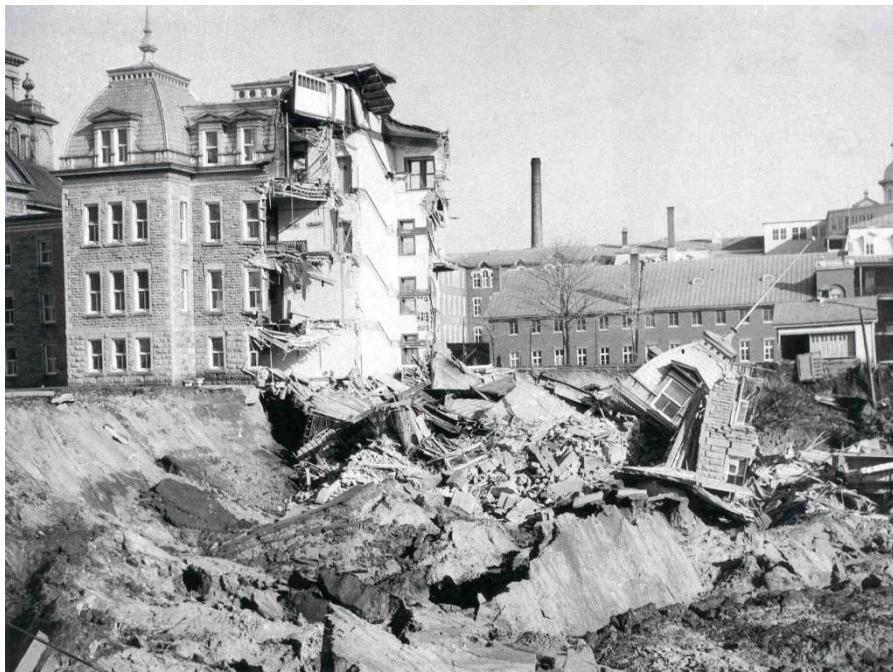
*Figure 8 : Bishop's palace partially destroyed by the landslide. Note the presence of a horst at the bottom right of the photo revealing the spread component of the landslide. (Source : Ministère des Transports et de la Mobilité durable)*

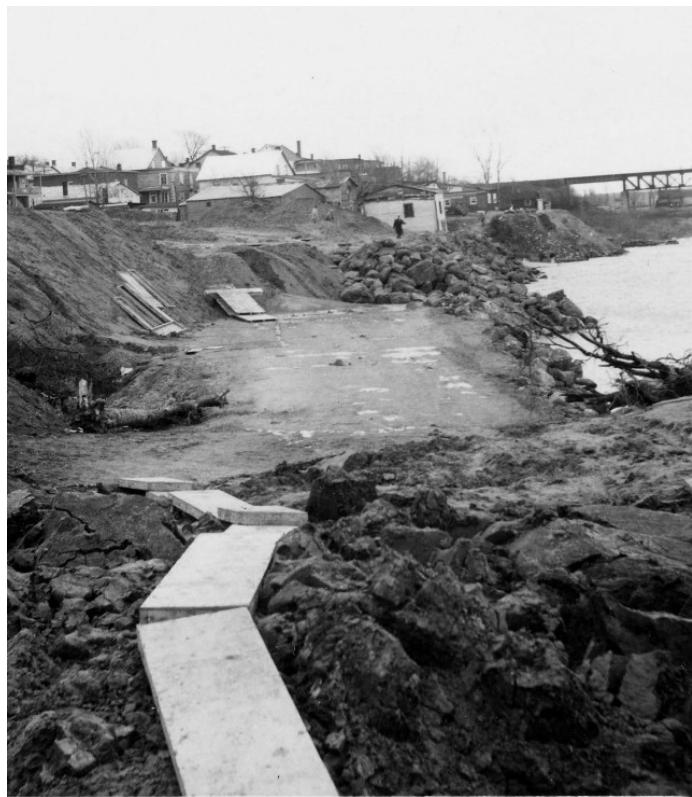
Figure 16 : Work in progress: riprap at the foot of the slope and cut in the slope. (Source : Ministère des Transports et de la Mobilité durable)

The location of buildings before and after the landslide is presented in Figure 15, providing insight into the extent of displacement and destruction. The initial failure likely occurred in the upstream part of the scar (Figures 16 and 17), at the site of a cutting made to install a riprap at the base of the slope (see on Figures 1 and 6). The first wave of debris, composed of soil from the slope and stones from the riprap (Fig. 1), was redirected after impacting the upwelling of the river bottom on the opposite bank, causing subsequent debris to flow downstream (Figure 18).

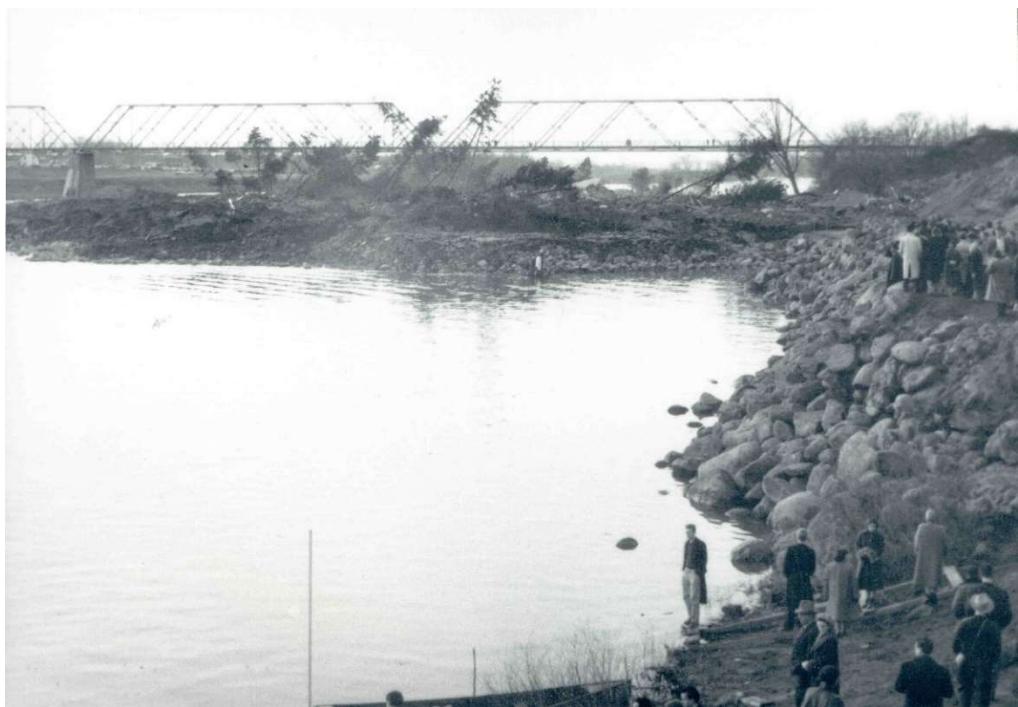
Figure 17 : Riprap upstream from the landslide and debris from the landslide. (Source : Ministère des Transports et de la Mobilité durable)

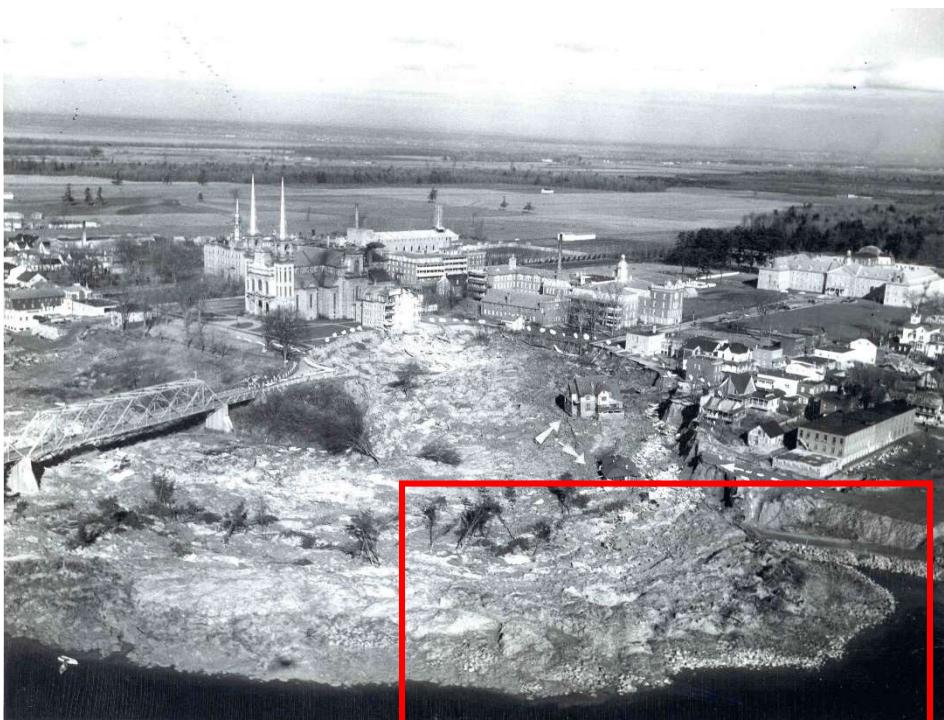
Figure 18 : Riprap swept away by the flowslide and cut in the slope. (Source : Gouvernement du Québec)

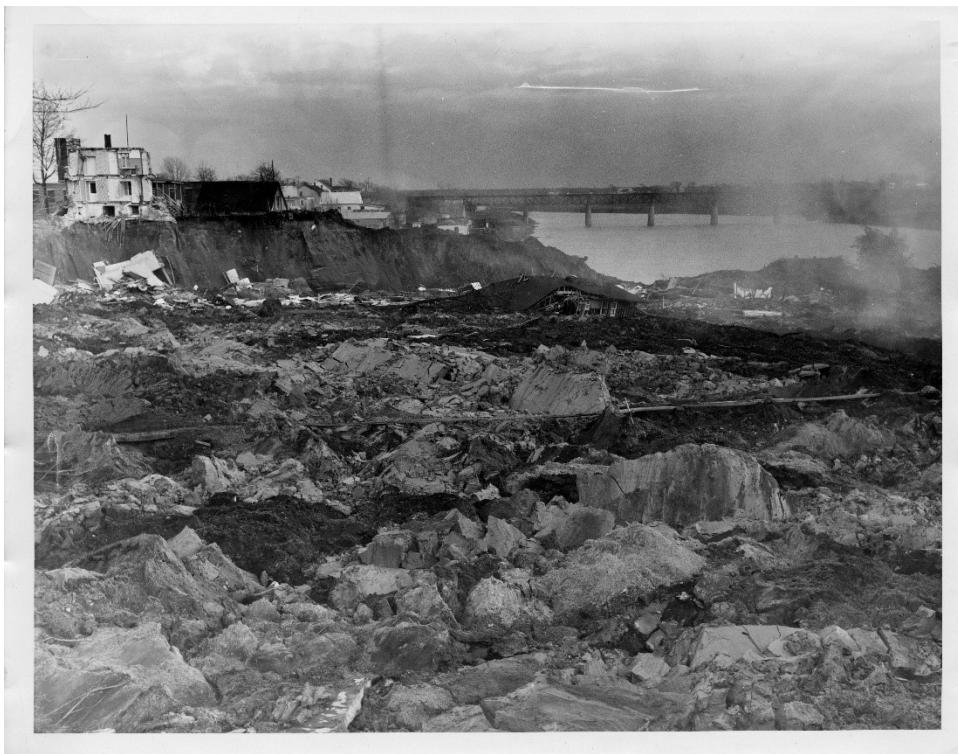
*Figure 19 : Debris partially remolded in the scar. Two horsts are visible on the right side of the photo.*  
(Source : Ministère des Transports et de la Mobilité durable, H. A. Beaudouin)

The area of the scar continued to expand, but the travel distance of the debris decreased. This is evident from the 55 to 75 m displacement of homes located on the east side of the scar, as shown in Figure 19, which also depicts the debris and a completely destroyed home. The long travel distances of the school and pine forest debris suggest very high fluidity, and imply that a temporarily high backscarp may have existed before the final failures, which carried away the homes and the bishop's palace over shorter distances.

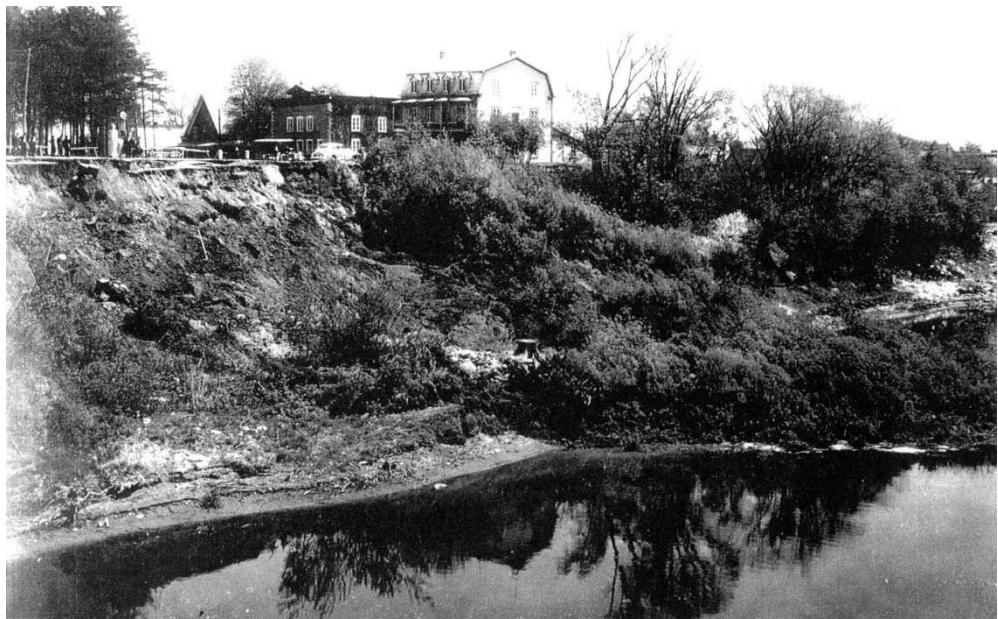
Figure 21 : Small-scale landslide in 1950. (Source : Ministère des Transports et de la Mobilité durable, Lucille Coulombe)

Revealing factors	<ul style="list-style-type: none"> <li>- Presence of two previous rotational slide scars, including one occurring in 1950 (Figure 21).</li> <li>- Presence of retrogressive slide scars along the shores of the Nicolet River, including a 7.5 ha scar directly upstream from the site (Figure 22).</li> </ul>

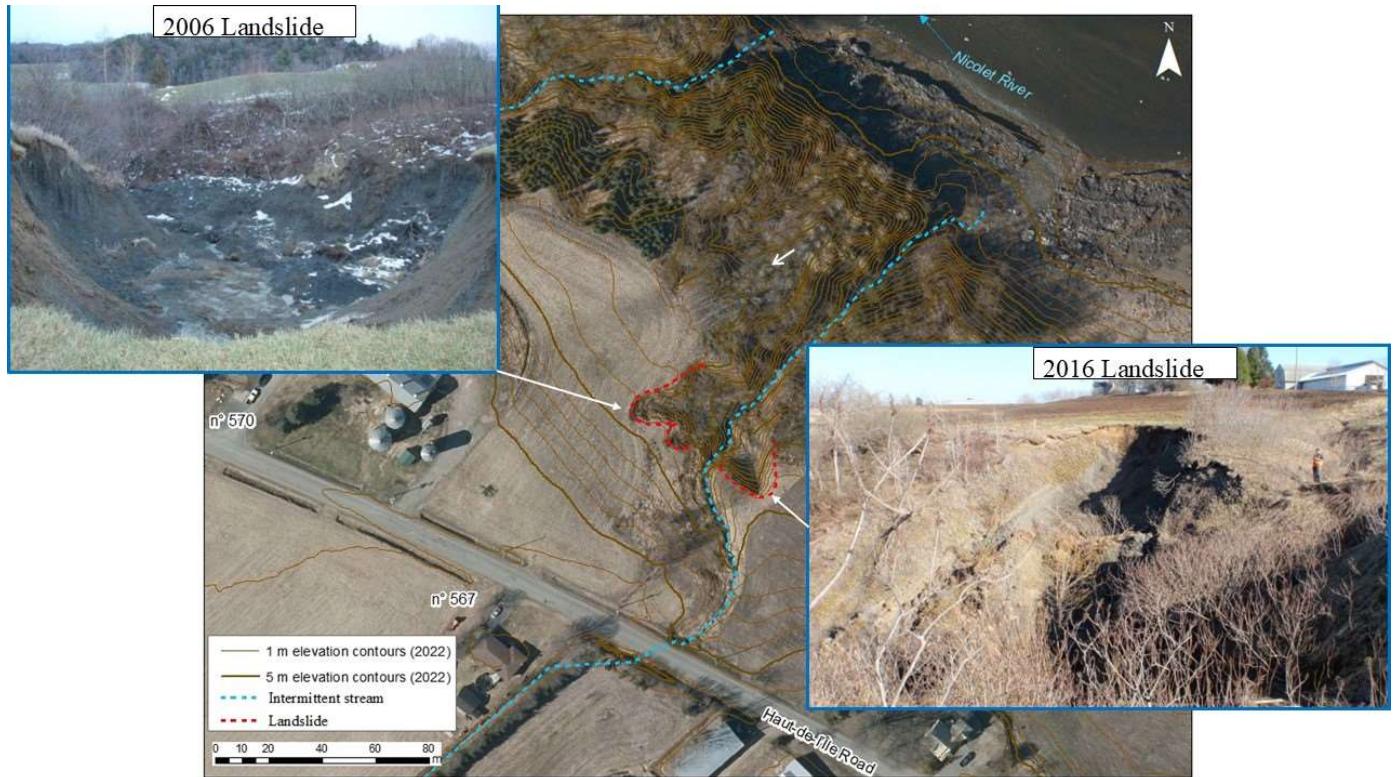
Figure 6: View of the 2006 and 2016 rotational landslides.

Rotational landslides were also observed along the ravine banks in 2006 and 2016 (Figure 6). These episodes reflect a common dynamic of slope movements linked to ravine erosion, which also led to the May 2025 flowslide.

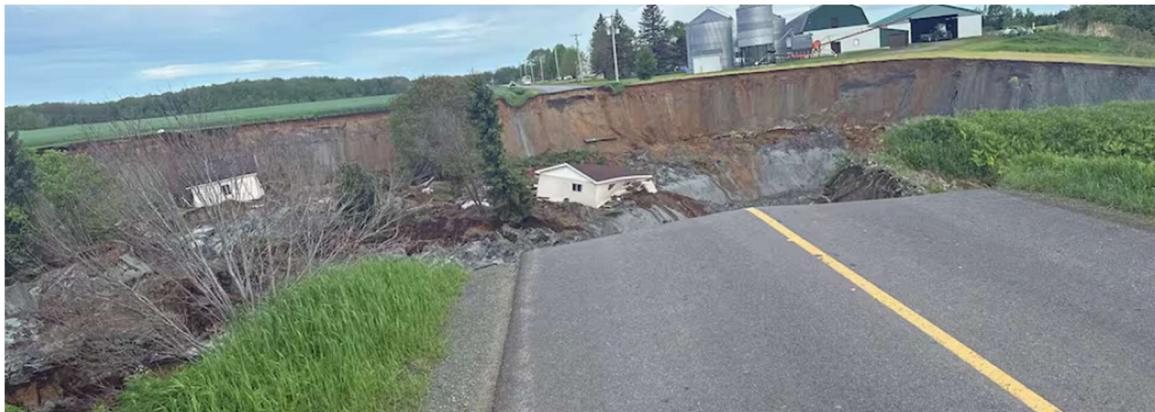
Figure 9: Photo showing the position of the secondary buildings of No. 567 in the early moments after the flowslide. Note that the larger building near the center of the photo is still above the second bench. (Source: Journal de Montréal, May 21, 2025, 8:26 a.m.)

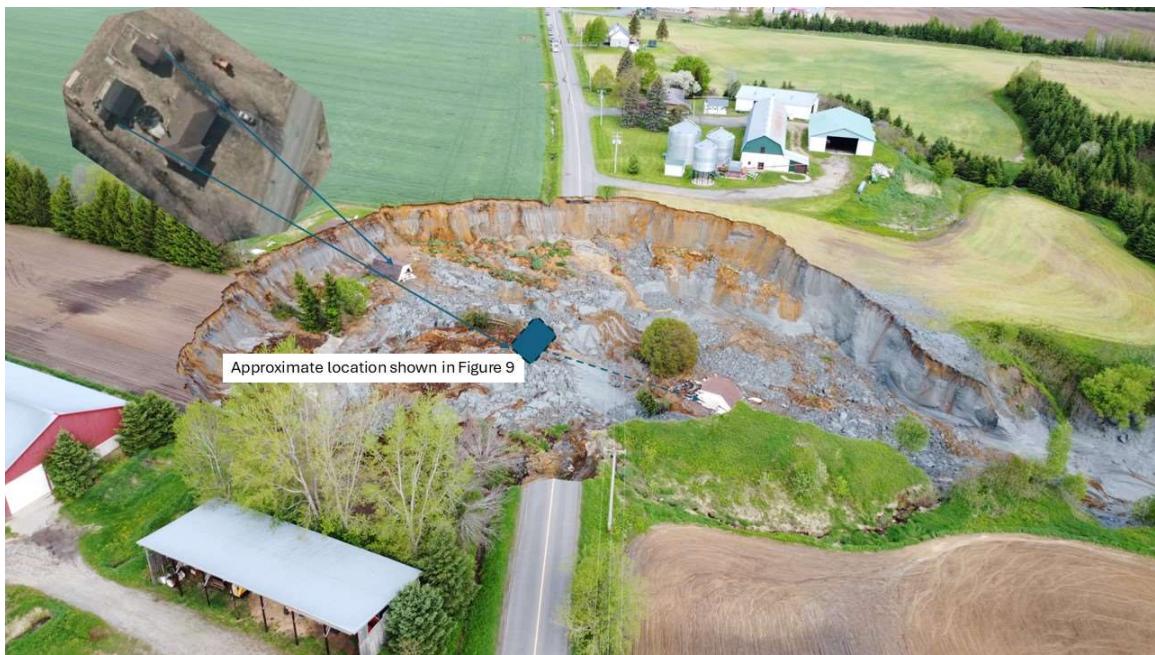
Figure 10 : Drone view showing the position of the secondary buildings of No. 567 around 8 a.m. on May 21, 2025. (Source: MSP)
