## Issues of highly retrogressive landslides in sensitive clays Champlain Sea Basin

3<sup>rd</sup> International workshop on

Landslides in sensitive clays

Technical tour

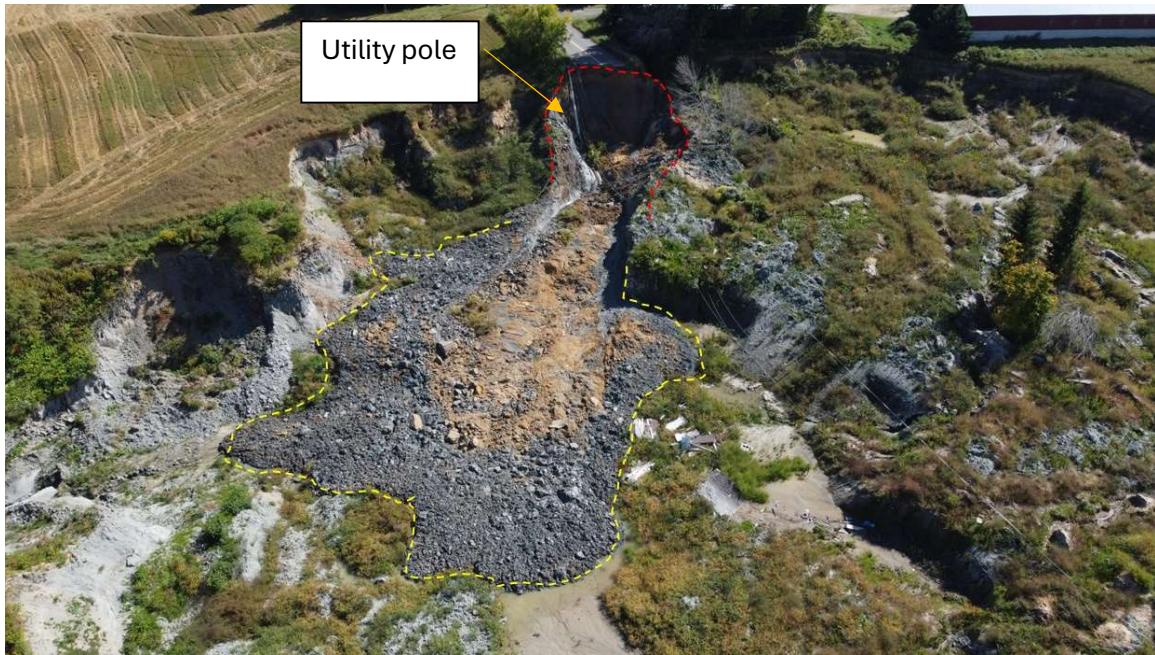
Figure 12 : Recent landslide (mid-September 2025) that toppled a utility pole. Note the significant remoulding of debris associated with this event.

Regular drone monitoring has been conducted since the landslide occurred on May 21, 2025. In the weeks following the event, the scarps of the scar progressively evolved, with most slopes becoming gentler. However, the lateral scarps flanking the lower bench—each approximately 14 m high—experienced significant retreat during the first two weeks, up to June 2 (Figure 11). Observations made in July and August indicated minimal changes to the scar's geometry. Nonetheless, two additional failures occurred in mid-September along the edge of the lower bench, confirming that the tallest scar walls remain unstable, and that debris continues to be subject to substantial remoulding (Figure 12).

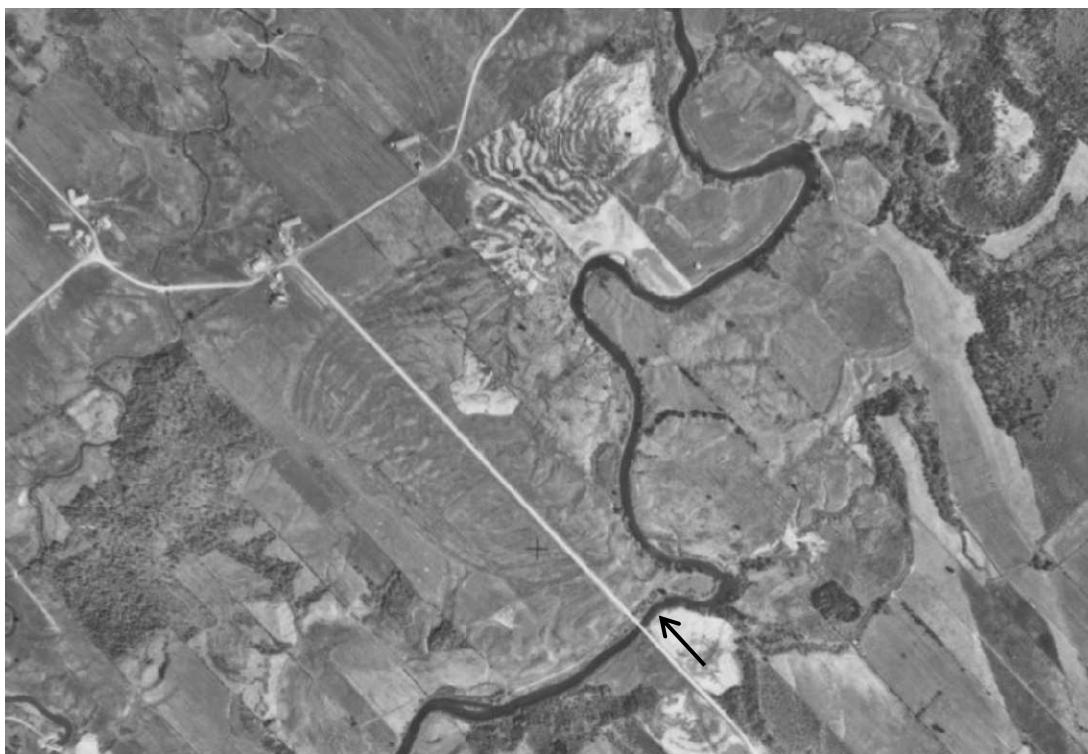
Figure 2 : Aerial photo from 1955 showing typical patterns of highly retrogressive landslides along the Noire River. The arrow points to the site of the 2022 landslide. (Source: photo A-14602-98 – Energy, Mines and Resources – Canada)

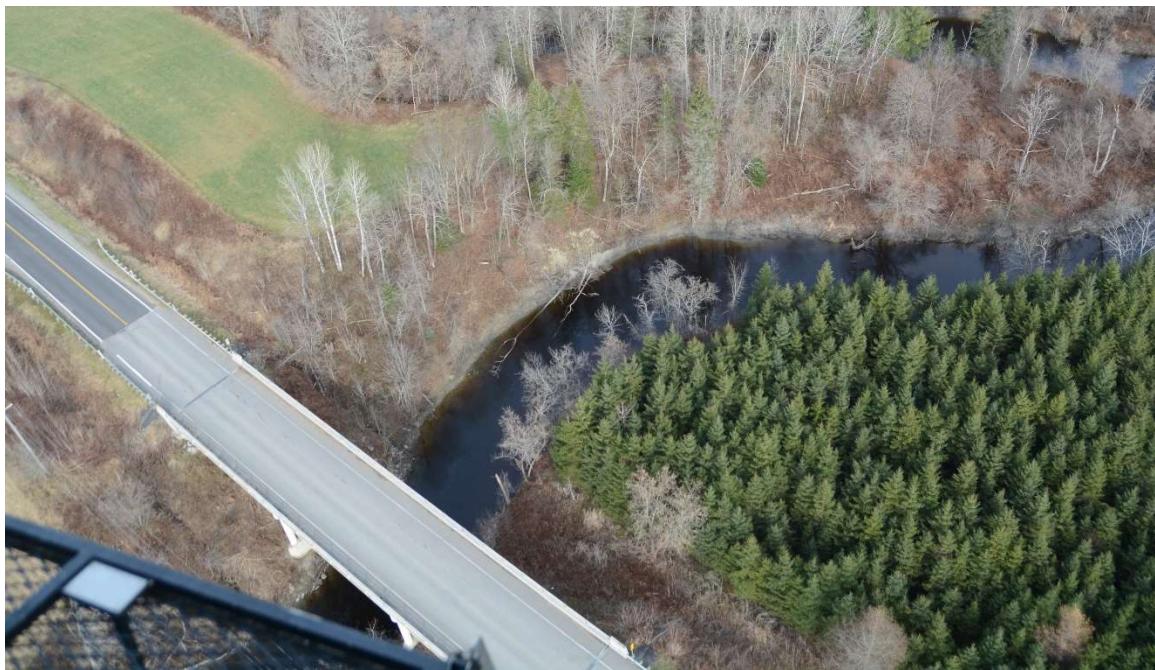
Figure 3 : Helicopter view in 2017 showing the presence of an erosion notch at the foot of the slope.  
(Source: MTMD – DGG)

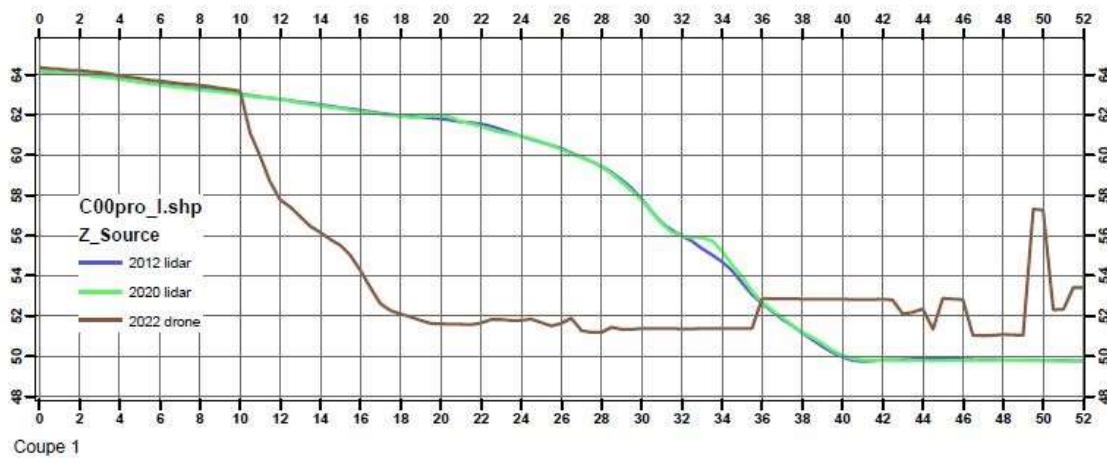
Figure 4 : Topographic section at the site of the 2022 landslide.

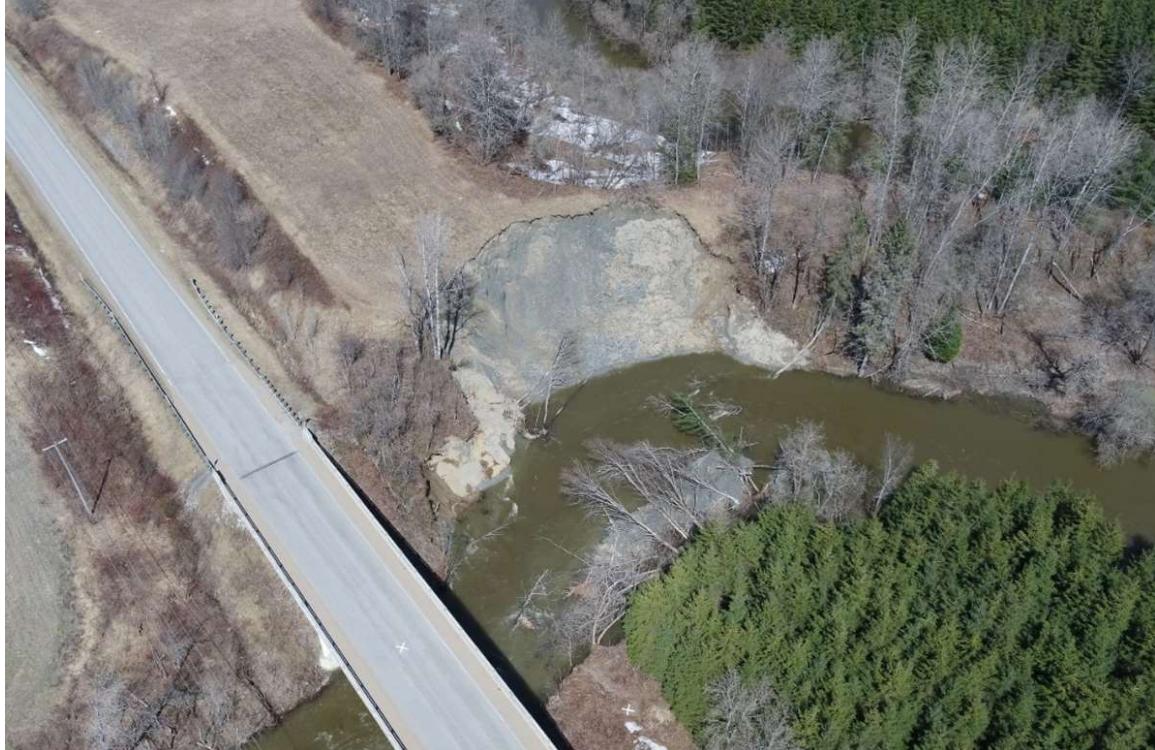
Figure 6 : Drone view of the April 2022 landslide along the Noire River, near the road and bridge on Saint-Philippe Road. (Source: MTMD – DGG)

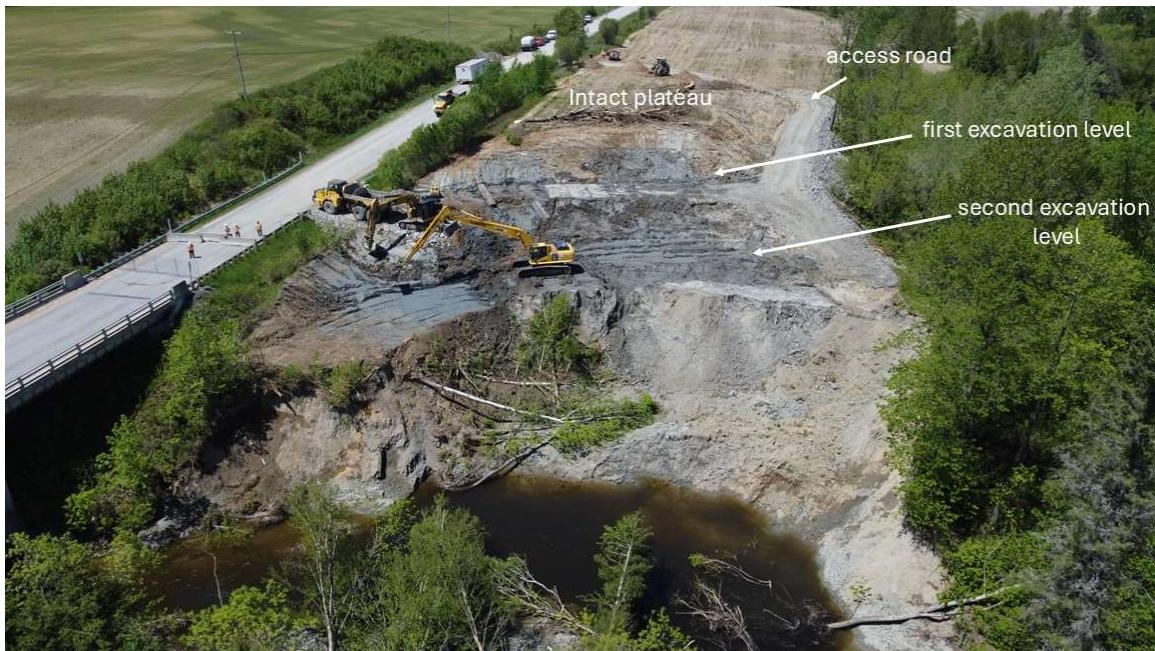
Figure 7 : Excavation of ground levels gradually approaching the landslide scar. The access road was placed in a location where it was lower than the adjacent intact plateau. (Source: MTMD – DGG)

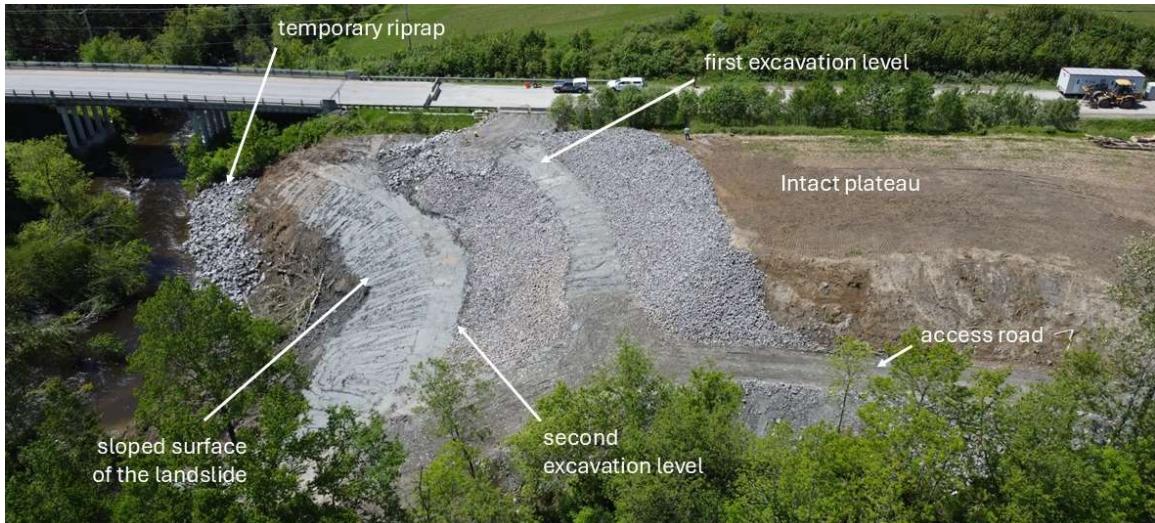
Figure 8 : View of the preliminary phase completed. (Source: MTMD – DGG)

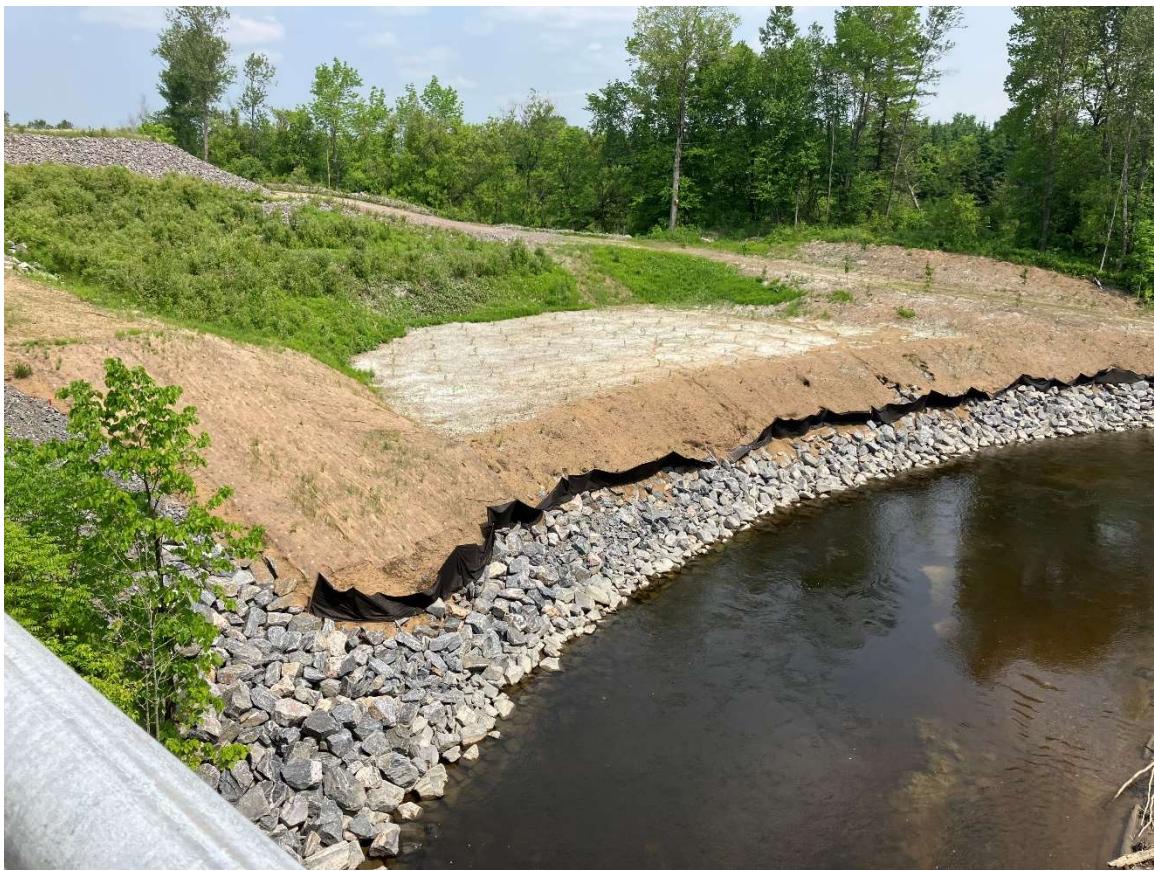
Figure 9 : View of the final works. (Source : MTMD – DGG)

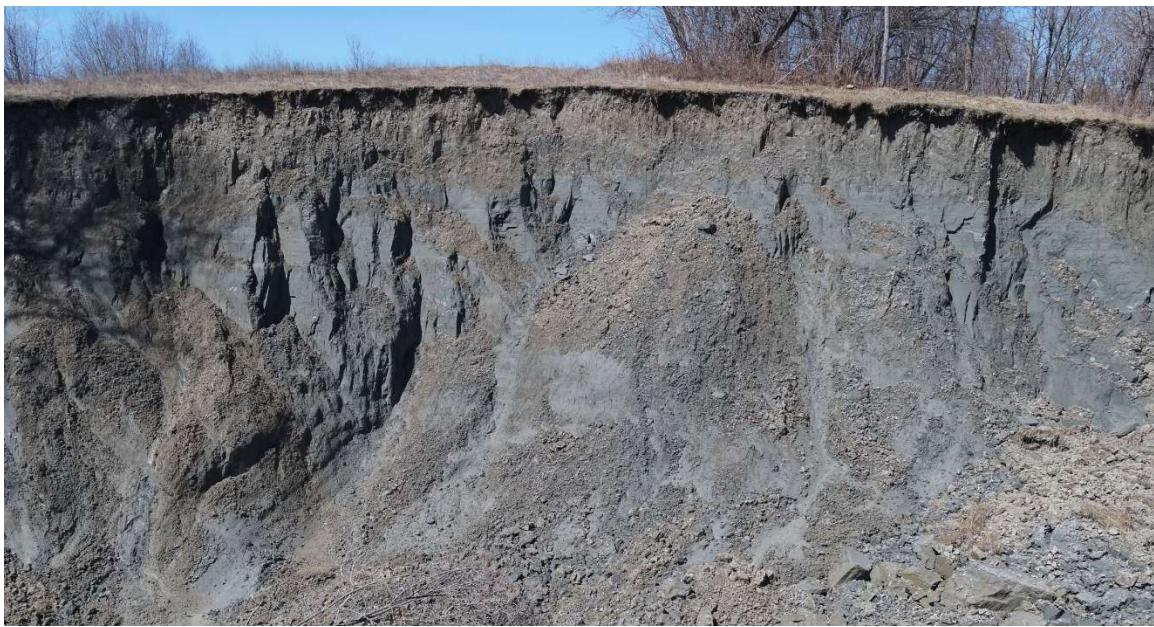
Figure 10 : View of the backscarp of the landslide, showing a well-developed system of very deep subvertical cracks.

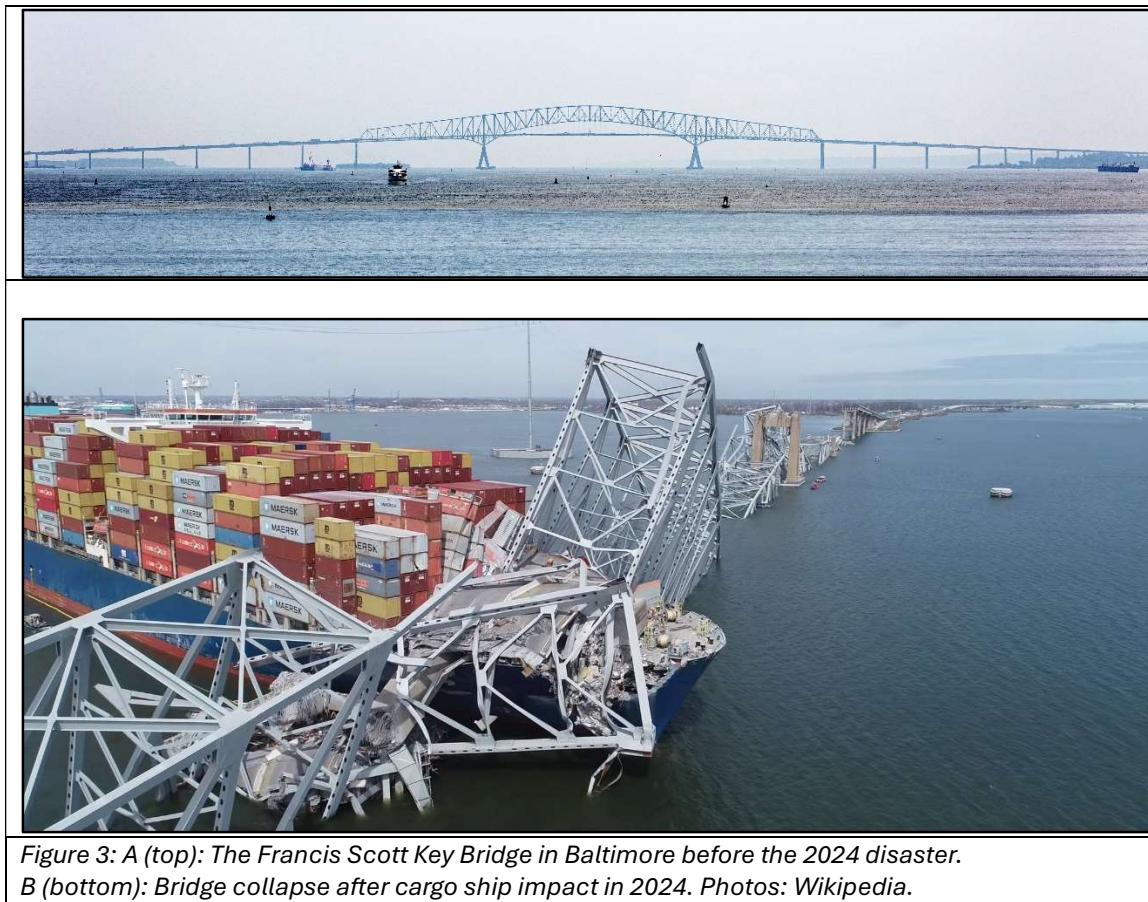
Figure 3: A (top): The Francis Scott Key Bridge in Baltimore before the 2024 disaster. B (bottom): Bridge collapse after cargo ship impact in 2024. Photos: Wikipedia.

A similar incident occurred at the Skyway Bridge in Florida in 1980, prompting the Canadian Coast Guard to assess the vulnerability of Canadian bridges to such impacts. A 1982 report identified the Laviolette Bridge as Canada's most vulnerable bridge to maritime collisions. The piers were deemed too narrow. The Quebec Ministry of Transportation therefore
